# MaK Parts Comparison Bulletin

### Piston Crowns – The Hidden Value of Genuine Components

The following points describe further engineering analysis, comparing a genuine REParts™ M43 chrome plated piston crown to a non-original welded and chrome plated piston crown, in their conformance to OEM dimensions, tolerances and metallurgical specifications. Further conclusions are drawn concerning the quality and benefits of REParts™ vs non-OEM welded piston crowns.

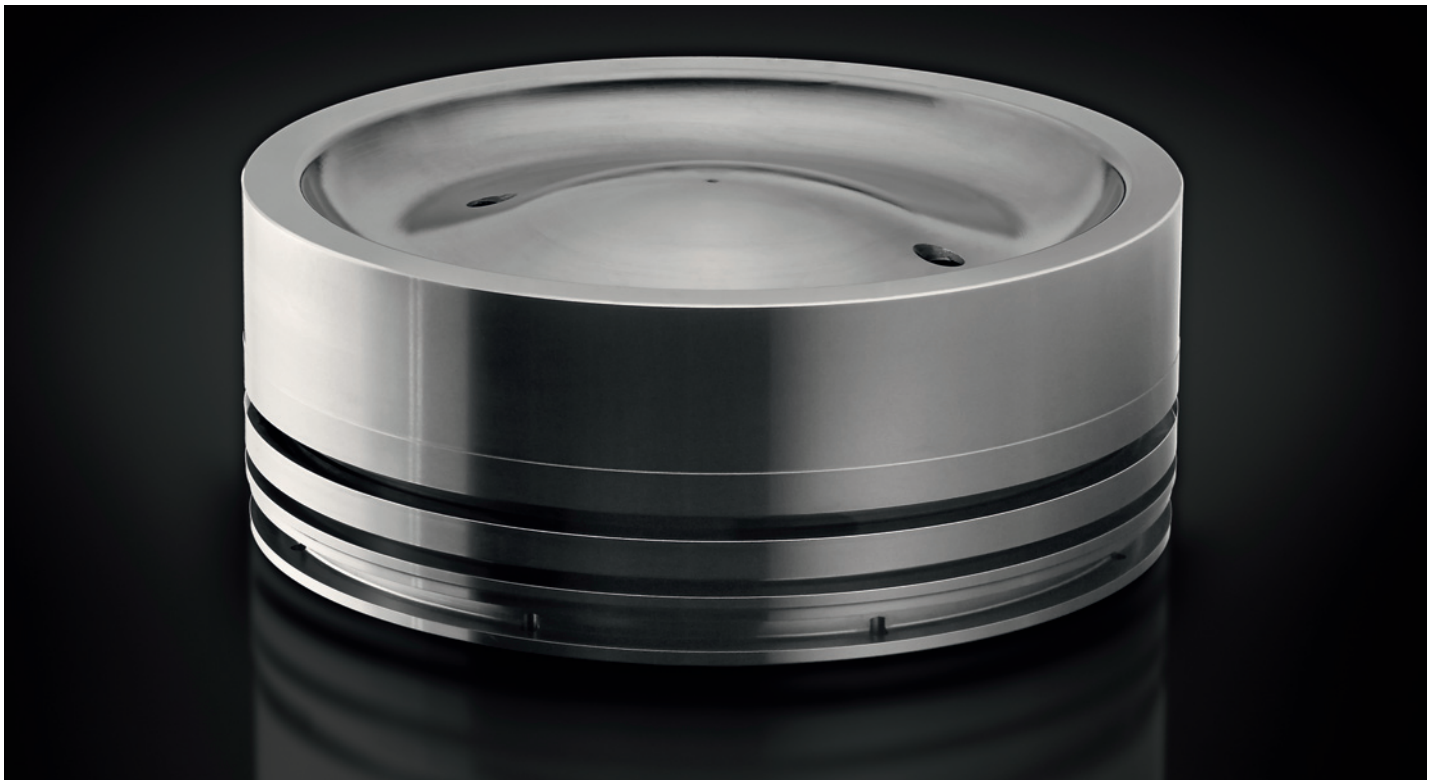
tion. REParts™ piston crowns are machined to the original OEM dimensions; this ensures correct fit to the piston ring as well as good distribution of gas forces to prevent instability of the piston rings and to reduce wear. The innovative REParts™ coating system provides maximum wear protection and is suitable for used piston crowns, which have or have not been coated, that require overhaul.

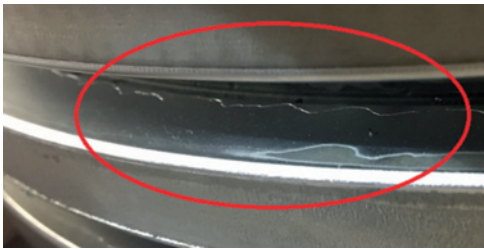
1. MaK piston crowns, overhauled through a non-genuine process, show chrome residues at the ring groove under cuts, causing abnormal piston ring dynamic, uneven contact surface and sharp edges. These can result in excessive wear on the first ring groove close to the OEM wear limits after few running hours.

Excessive wear on the first ring groove.
