Turbine blade and nozzle ring repairs

Turbocharger division

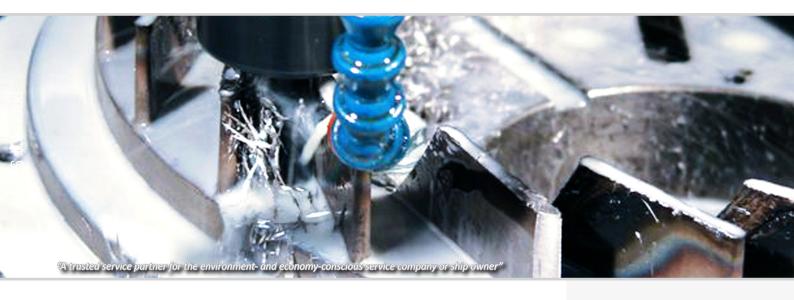
PJ Diesel is often able to repair damaged turbine blades. This is done by a specialized procedure carried out by highly qualified technicians operating in accordance with class approval.

The turbine blades are dismantled, cleaned ultrasonically and accurately measured. An UV inspection is then carried out to detect possible fractures. Fractured blades are replaced with new ones.

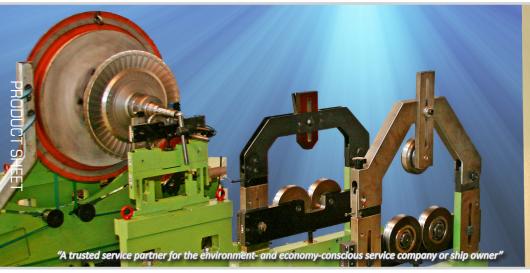
PJ Diesel engineering have the latest equipment for balancing rotors in two planes from the smallest size up to 3000 mm length/1200 mm diameter.

All balancing in accordance with ISO, API® and MIL specifications
